A PICTORIAL STUDY OF
**SEISMIC
 DAMAGE**
 AND THE USE OF
 PROPER SAFEGUARDS.

SD-100

On an early January morning in 1994, the Northridge area of Southern California was shaken by an earthquake that measured 6.6 on the Richter scale and lasted approximately 30 seconds. The repercussions are still being felt throughout the engineering community.

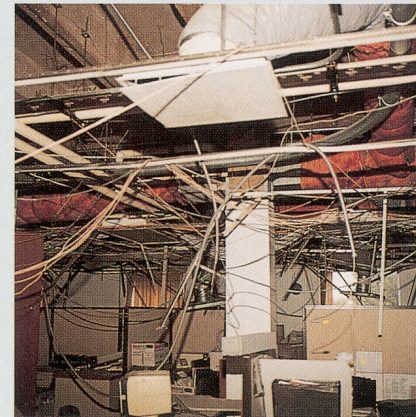
LAY IN SUSPENDED CEILINGS

Suspended ceilings sustained damage in many installations, because sway wires were not used at all or installed improperly. Damage was extensive and very dangerous to people in the spaces below. Fortunately, the earthquake occurred when most offices were not occupied. Forces in this location were 0.2gV and 0.25gH.

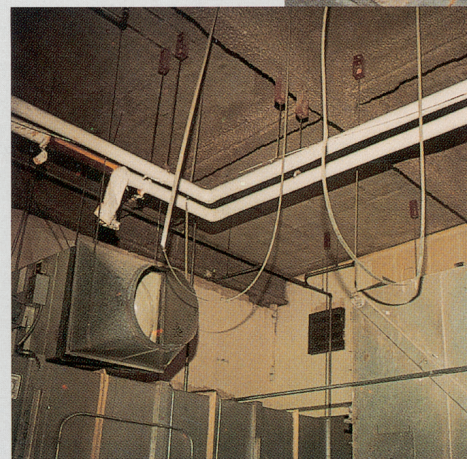
Duct work is very susceptible to seismic damage. Notice the straps that held the ducting that is now on the floor shown in Photograph to the left. This can be prevented by the use of sway bracing to limit sway and keep the duct work in place. Input was 0.15gV and 0.2gH.

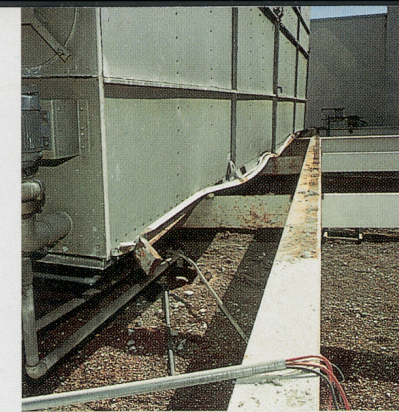
The independent rails rotated around their longitudinal axis, snapping anchor bolts and bending the cooling tower base. The problem could have been prevented by using a one piece structural base and double acting snubbers.

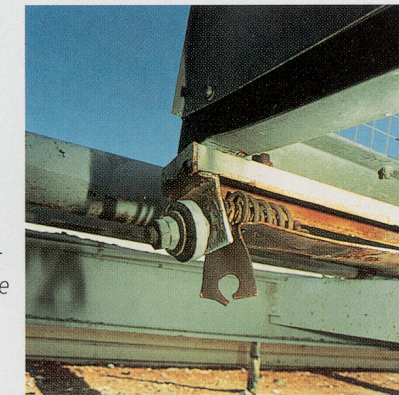
The vertical snubber bolt could not prevent the rail rotation. The anchor bolt tore through the base plate and the support springs fell over.

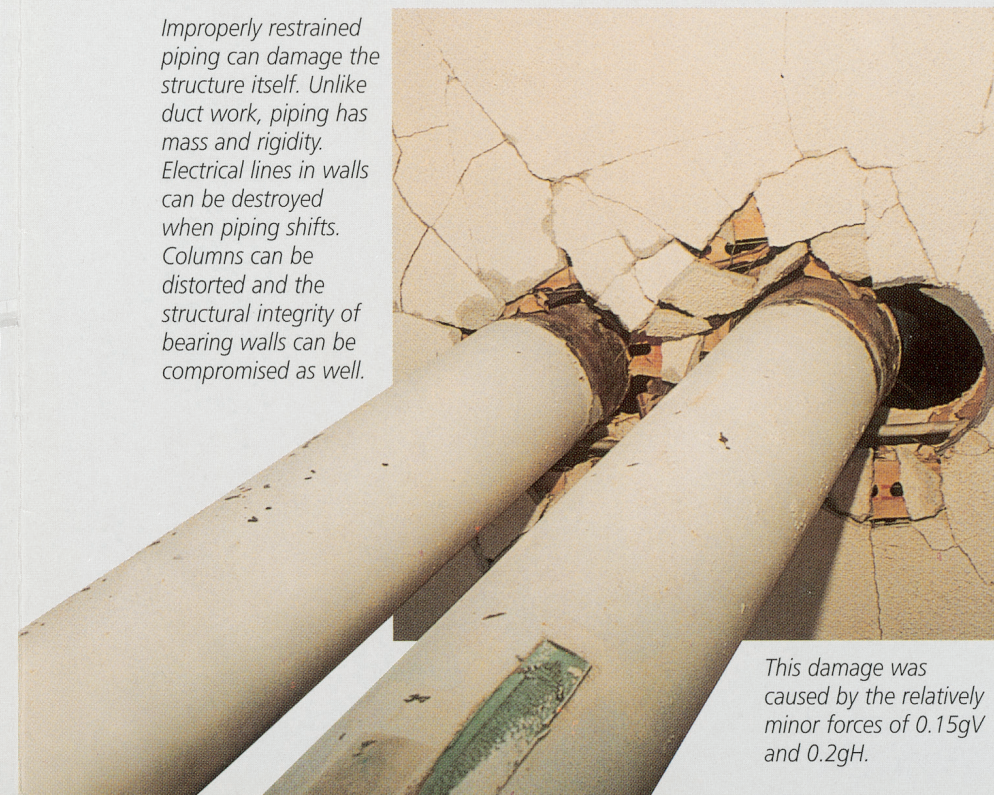
Improperly restrained piping can damage the structure itself. Unlike duct work, piping has mass and rigidity. Electrical lines in walls can be destroyed when piping shifts. Columns can be distorted and the structural integrity of bearing walls can be compromised as well.

This damage was caused by the relatively minor forces of 0.15gV and 0.2gH.

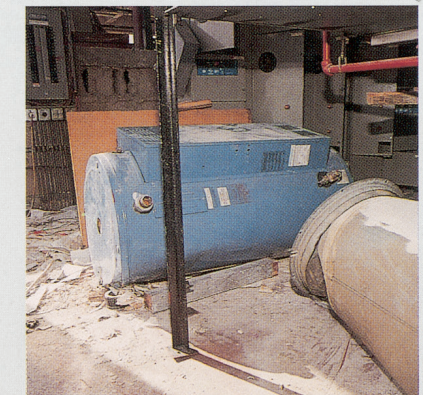
WATER HEATER

Water heaters have high centers of gravity and tend to turn over easily. The forces on this particular installation were 0.15gV and 0.2gH, heaters should be bolted to the floor and strapped to the nearest wall or column.

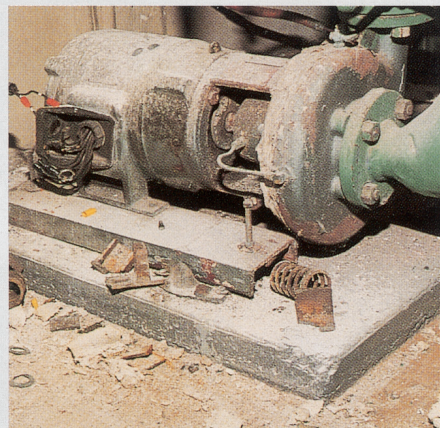
Gray cast iron spring housings invariably shatter as shown. The shrapnel flies in areas that may be occupied by plant room personnel. The only acceptable castings are ductile iron or cast steel.

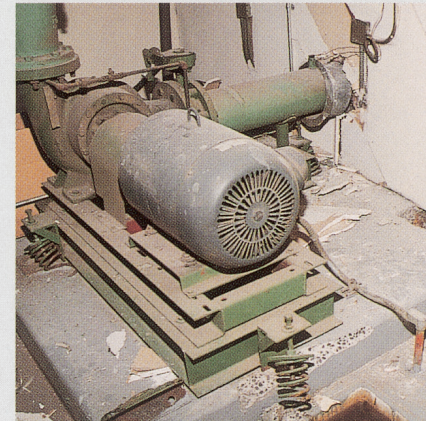
Another example showing free standing springs cannot be used without snubbing devices. The anchor bolts under these spring mountings were too close to the edge, and broke the housekeeping pad. Forces were relatively low at 0.2gV and 0.25gH, but more than sufficient to create havoc on this unsnubbed, resonant system.

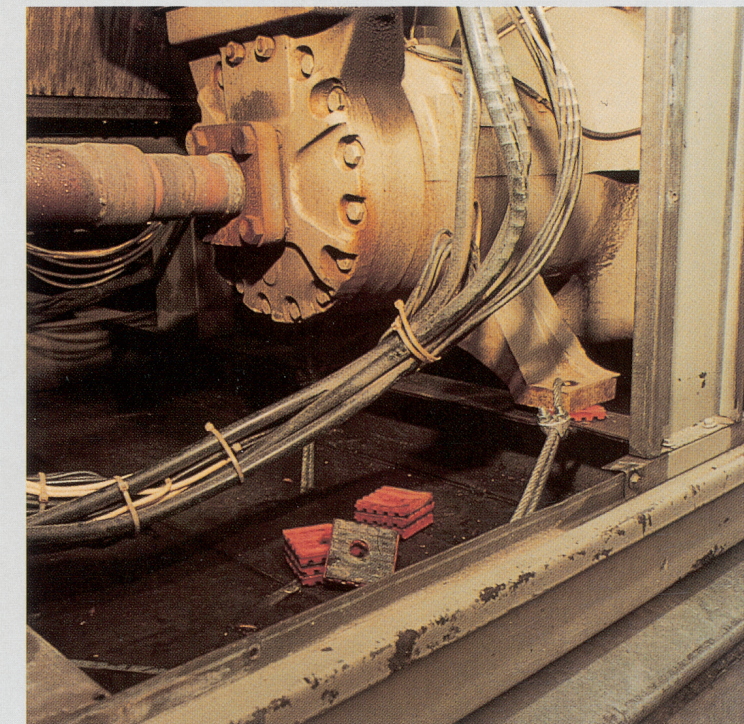
The cable system is an emergency measure to try to keep the compressor in place in anticipation of after shock. Forces were small at approximately 0.15gV and 0.2gH. Equipment with hard mounted internal components and external cushioned seismic isolation systems have a better chance of remaining operative.

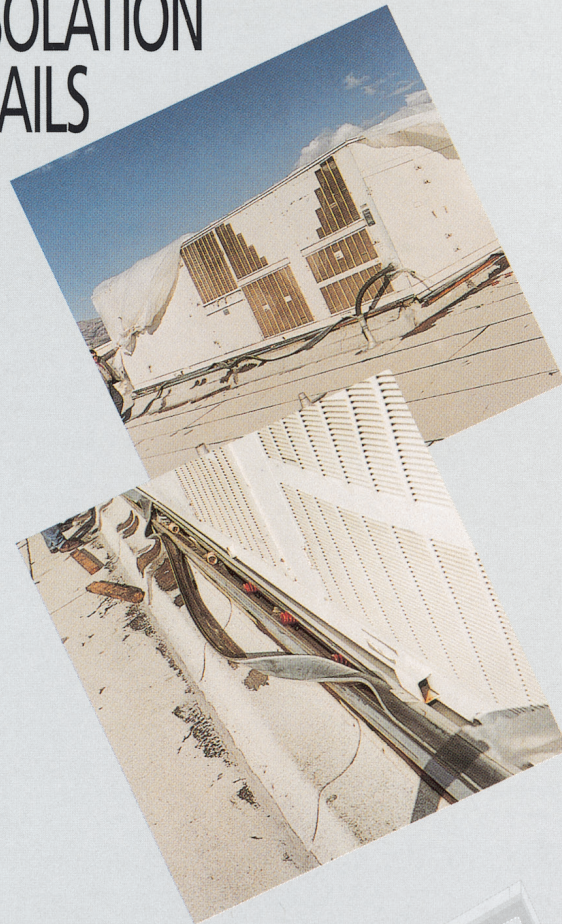
ALUMINUM ISOLATION RAILS

Curb top aluminum isolation bases have very little structural capability and generally fail. These failures are difficult to repair as the roof seldom allows for rigging, and the unit has to be lifted by helicopter or crane before bases can be replaced. Forces were small at 0.1gV and 0.15gH. The problem could have been prevented by using a seismically OSHPD approved complete isolation curb for the same application.

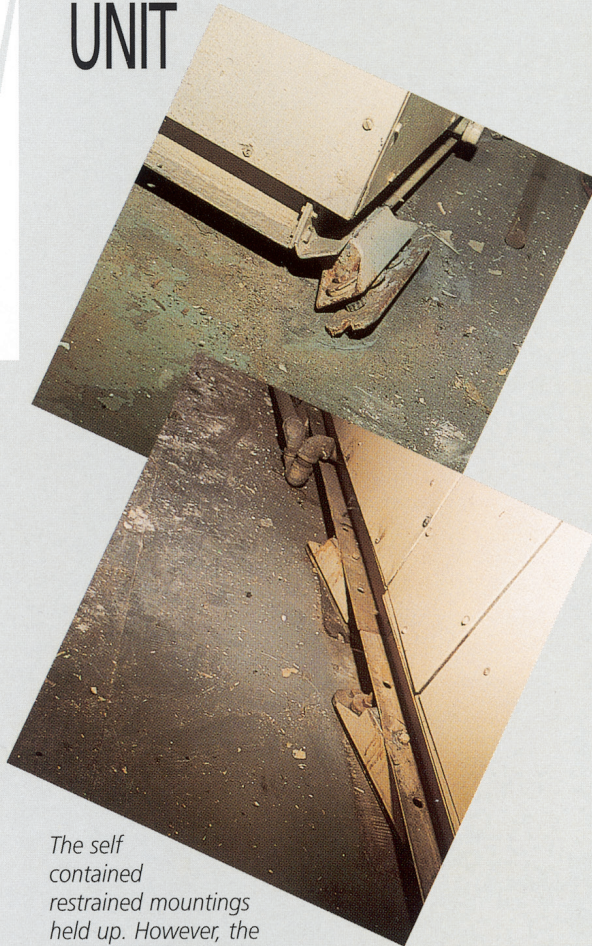
The self contained restrained mountings held up. However, the formed channel base deformed badly and the mounting anchors let go. All of the isolators either rotated or shifted. Part of this problem was the use of slots in the base plates rather than holes. Slotted holes simplify installation, but they are single acting and minor shifts allow one end to escape the anchor bolts and the other to follow. The system would have survived had it been mounted on a steel frame with adequate anchor bolts through base plate holes. Forces were not high at 0.15gV and 0.2gH.

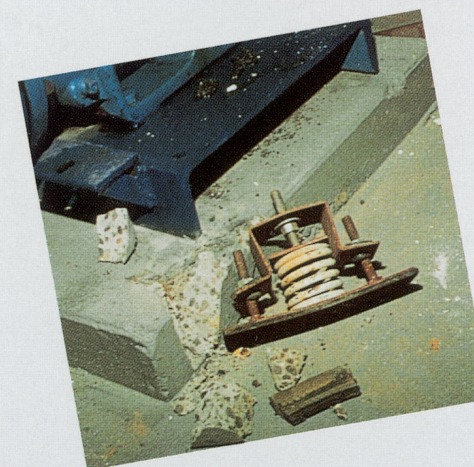
Housekeeping pad failures were common, because of improper doweling or fastening to the structural floor, and inadequate or no reinforcement in the pad itself. These pads, as the pads on the cover, had both problems. Inadequate fastening allows the pads to lift, chatter and shift. Poor reinforcement allows breakage. When the pads fail, the system must fail as nothing remains in place.

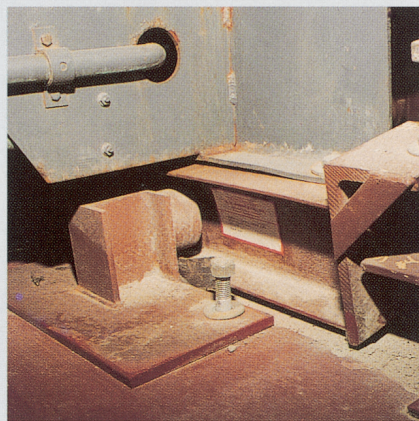
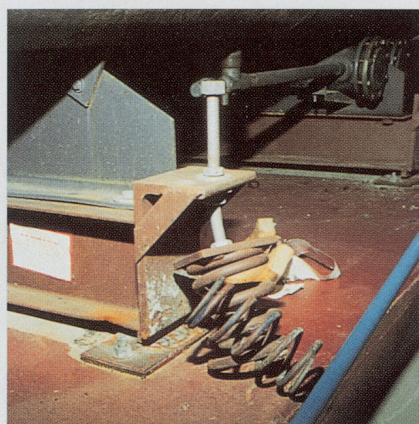
The anchor bolts were too close to the edge of the concrete housekeeping pad for the concrete to offer adequate resistance to the horizontal anchor bolt forces. The edges broke off so the anchor bolts were freed. This total failure of the restraint system occurred at only 0.15gV and 0.15gH. The mountings themselves showed considerable distortion as well.

Rails rotated in virtually every application. In the upper photograph the rotation was initiated by the horizontal snubber pushing against the web of the beam. In both photographs the springs were secured by welding. Welding is always poor practice as the intense heat embrittles the spring so it tends to snap at the weld and scale inclusions produce welds that pop off. All systems failed with pipe breakage in addition to the other problems.

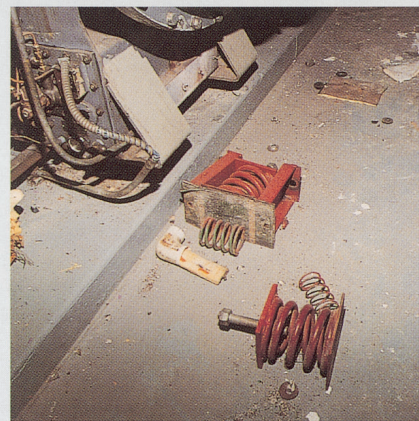
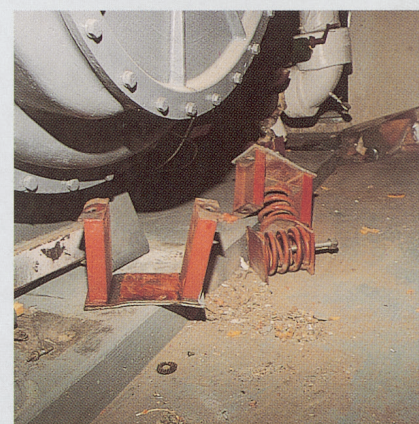
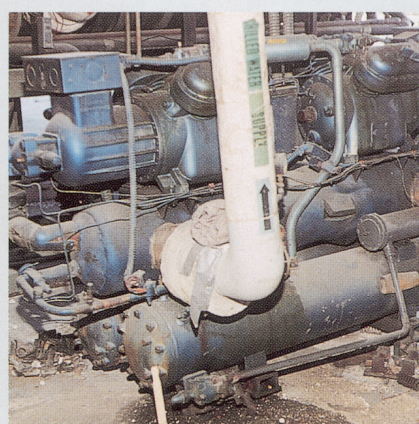
Another example of gray iron mounting failure. Fragments shown in the lower left and lower righthand corners can be dangerous to building personnel as well as equipment. Not only is the compressor out of service, but there is the additional worry of potential liability and damage.

Some chillers can be directly mounted on spring isolators, but not as shown in photographs above. Seismic forces were reasonably high at 0.3gV and 0.6gH. Not all the parts are shown in the photographs, but both the restraining bolts between the upper and lower housings and the anchor bolts failed. The top plates came free of the rest of the housing and may still be attached to the chiller. Base plates were weak and showed distortion. Mountings rated by test with OSHPD pre-approval would have been far safer. The chiller dropped some 14" in addition to shifting.

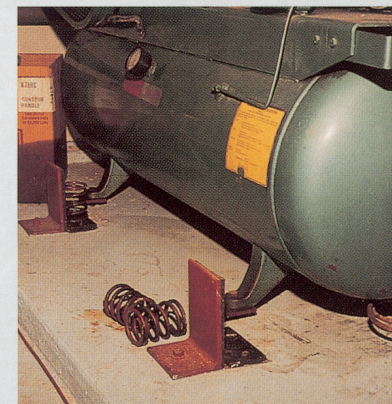
The spring mountings under this air compressor failed, because the snubbers were not all directional. Single bolted restraints can rotate. This angle had a simple pad cemented to one face. The arrangement could only contain the system transversely rather than in all directions. As is typical, the equipment resonated and the springs fell over. Forces were about 0.25g Vertical and 0.35g Horizontal. Proper all directional snubbers would have solved the problem.

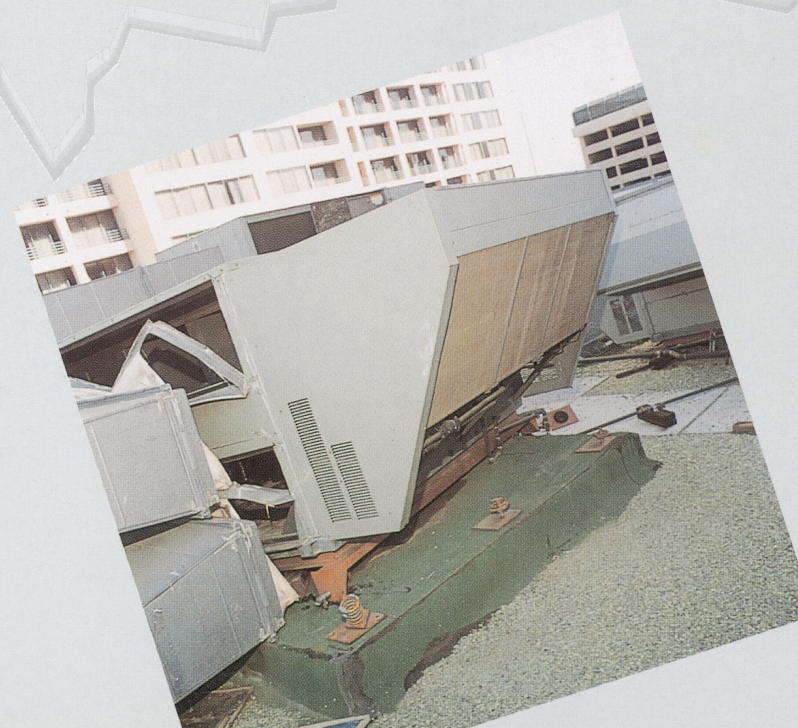
Using a poor copy of a good snubber can result in disaster. Rather than a snubber made with a one-piece double acting, all directional Neoprene sleeve with washer faces, this hard rubber washer was cemented to the angle. The rubber bushing does not appear to be thick enough. The minor cost saving, if any, resulted in a dramatic, costly failure and major equipment displacement.

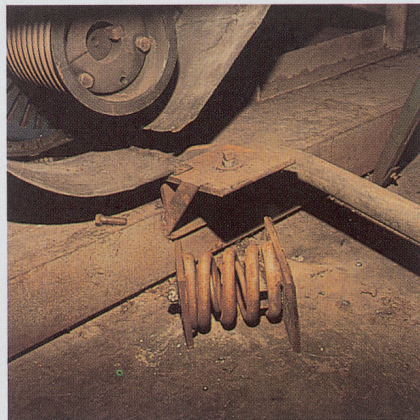
This close up of the spring shows that the attachment bolt broke allowing the spring to shift and fly free. (The spring was moved back for the photograph.) This would be a dangerous missile anywhere, but particularly in an equipment room with electrical devices. Proper snubbing would have controlled the situation.

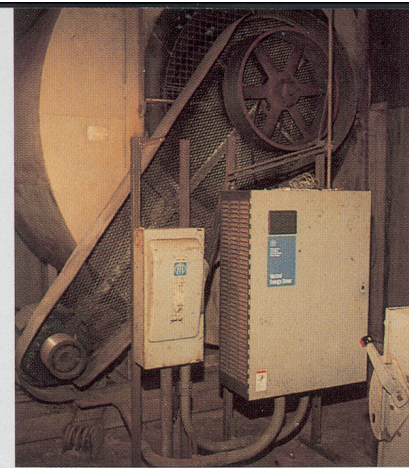
Spring isolators must be used with seismic snubbers to prevent resonance at seismic frequencies. When the horizontal amplitude became excessive, the whole system shifted releasing the springs while still compressed to 1,500 lb. This sudden release of energy can do damage to anything in the path of the flying springs. Unsnubbed systems not only fail, but they can be dangerous even at low input figures of 0.15gV and 0.12gH.

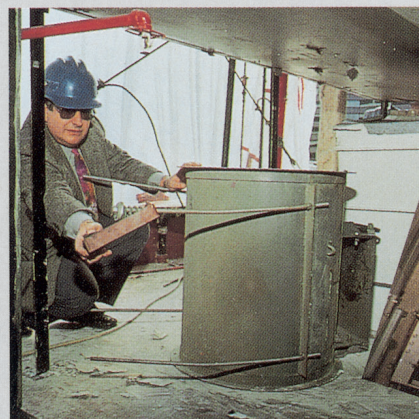
This small tubular fan broke free of the ceiling and landed on the mechanical room floor. It could have caused severe injury or equipment damage. Electrical lines and control panels are particularly sensitive. This swinging almost always takes place when seismic energy is applied to suspended systems. Proper cable sway bracing would have limited the pendulum action.

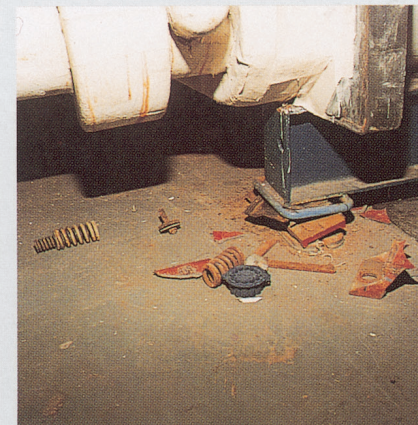
Here is another example of ragged, shattered pieces of cast iron. Cast iron should not be approved for seismic work regardless of the force levels. The systems were subjected to low inputs of 0.2gV and 0.25gH.

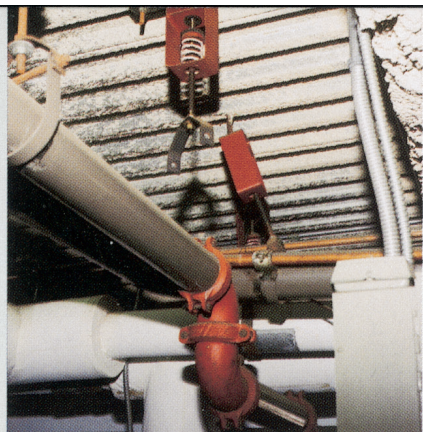
The clevis hanger in the center of the photograph fell apart and the rear hanger clevis is sufficiently displaced to have bent the ceiling bolt. There are chatter marks on the pipe in the front clevis, all indicating that this system went into resonance even though the accelerations were only 0.15gV and 0.2gH. Proper sway bracing, axial restraint and upper limit stops could have prevented this damage.

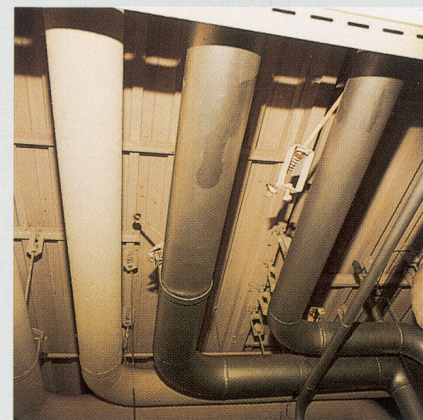
Piping without sway braces will shift position and change elevation. One hanger broke completely free and one pipe is displaced approximately 12" from its original location. On other jobsites, piping systems came down. Sway bracing and axial restraint is essential along with vertical limit stops at anchorage locations. Clevis bolts must be sleeved or braced as well.

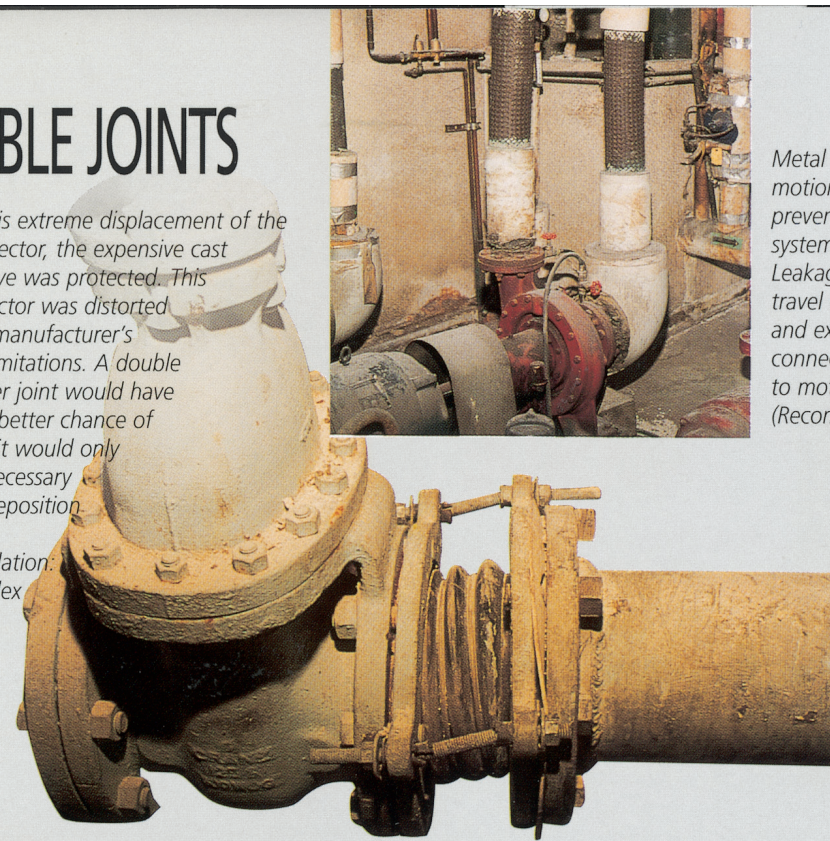
Even with this extreme displacement of the flexible connector, the expensive cast iron gate valve was protected. This teflon connector was distorted beyond the manufacturer's movement limitations. A double sphere rubber joint would have had a much better chance of survival and it would only have been necessary to properly reposition the piping. (Recommendation: Mason Safeflex SFDEJ)

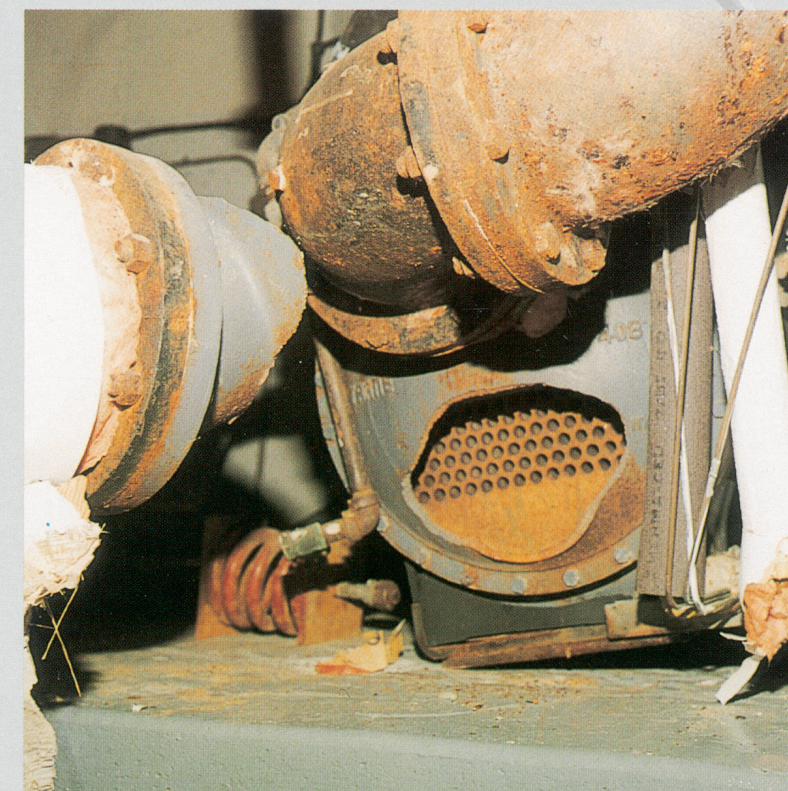
An excellent example of equipment failure at the piping interface. Both the restrained equipment and piping move out of phase during an earthquake and the cast shells are not designed to accept the force necessary to drag the piping. Cast component failures are common. The solution is installation of a spherical twin sphere rubber expansion joint to allow for the motion.

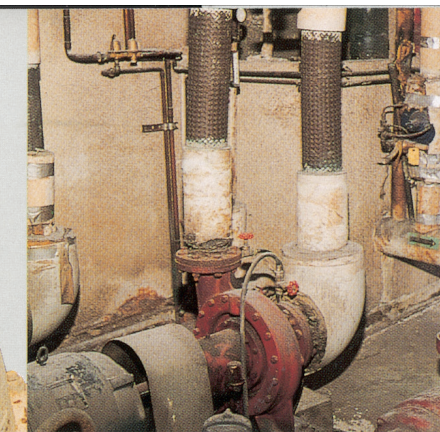
Metal flexible hose is designed to accept motion at right angles to the axis. The hoses prevented pump body failures, but after the system was back on line, the hoses leaked. Leakage was caused by metal fatigue, over travel transverse to the axis or compression and extension. Double sphere rubber connectors are all directional and can respond to motion in any direction without failure. (Recommendation: Mason Safeflex SFDEJ)

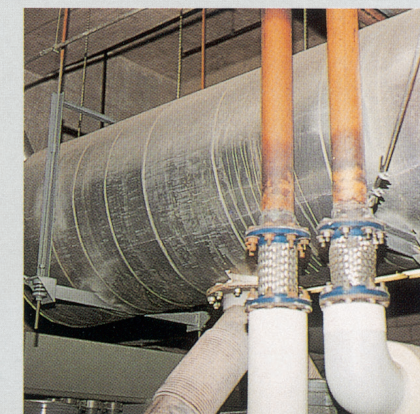
The metal flexible hose prevented pipe failure. However, the metal hose on the right was compressed. Braided metal hoses cannot accept compression and it had to be replaced. Flexible metal joints do not have the same movement capabilities as rubber joints, and tend to fail under seismic conditions. The seismic input was 0.15gV and 0.2gH. (Recommendation: Mason Safeflex SFDEJ)
