A PICTORIAL STUDY OF
**SEISMIC
 DAMAGE**
 AND THE USE OF
 PROPER SAFEGUARDS.

SD-100

On an early January morning in 1994, the Northridge area of Southern California was shaken by an earthquake that measured 6.6 on the Richter scale and lasted approximately 30 seconds. The repercussions are still being felt throughout the engineering community.

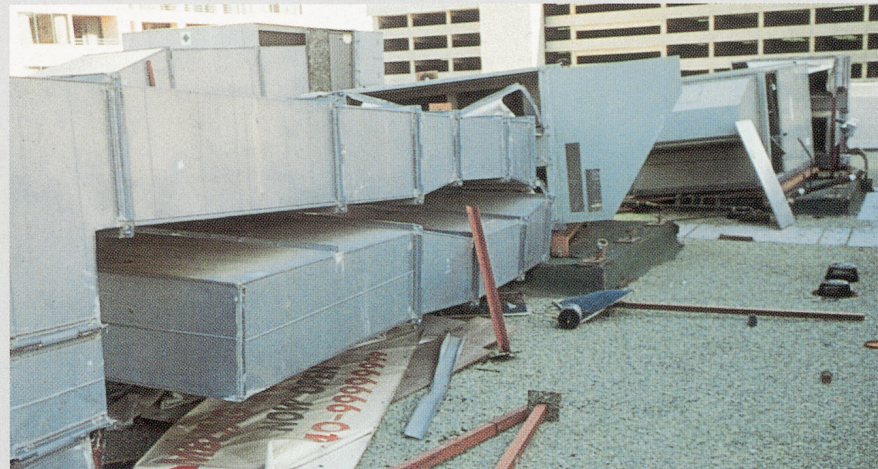
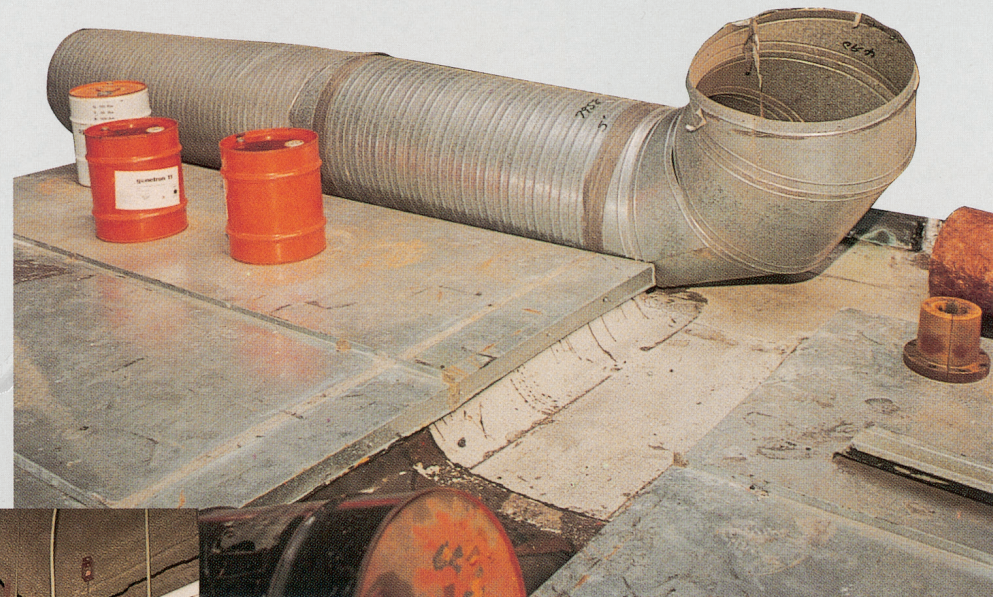
The roof mounted ducts were supported by the steel columns. The four columns were not interconnected, because the loading was so light. However, horizontal forces were large enough to cause failure as the supports were not cross braced to form one integral unit.

Duct work is very susceptible to seismic damage. Notice the straps that held the ducting that is now on the floor shown in Photograph to the left. This can be prevented by the use of sway bracing to limit sway and keep the duct work in place. Input was 0.15gV and 0.2gH.

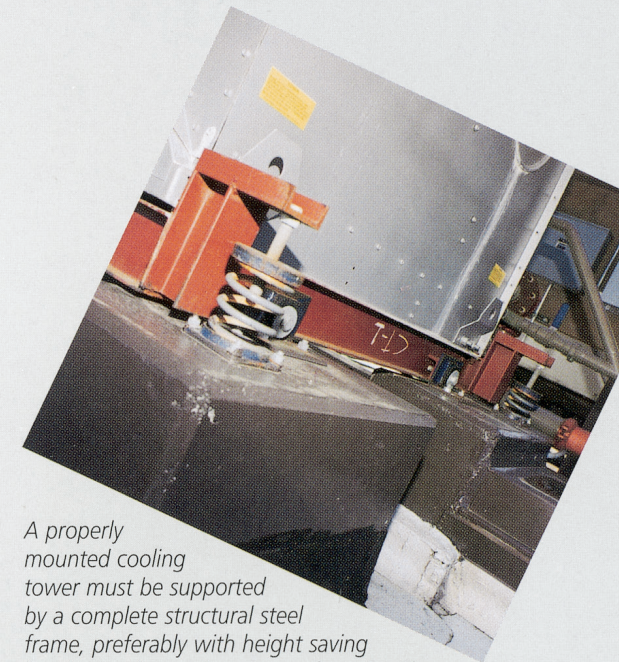
A properly mounted cooling tower must be supported by a complete structural steel frame, preferably with height saving brackets to lower the center of gravity. The free standing spring mountings need not be bolted down, as the blue all directional seismic snubbers next to each spring, limit the spring's motion. These all directional seismic snubbers are shown in Chapter 49 of the 1991 ASHRAE Guide Application Manual. Snubbers are double acting and selected for maximum calculated forces. Springs should be positioned within holders rather than welded to avoid cracking. Adequate edge distance to snubber anchor bolts is extremely important (Mason WF Base, SLF Spring Mountings, Z-1225 Snubbers).

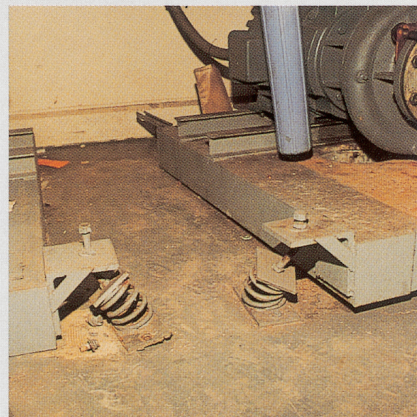
This is an excellent installation using all directional seismic snubbers to prevent the concrete bases going into resonance as would happen if the springs were used alone. There is no reason to bolt the springs to the floor as the snubbers restrict motion and the springs do not shift on their friction pads. Snubbers must always be anchored with proper anchor bolts. (Mason BMK Bases, SLF Spring Mountings, Z-1225 Snubbers)

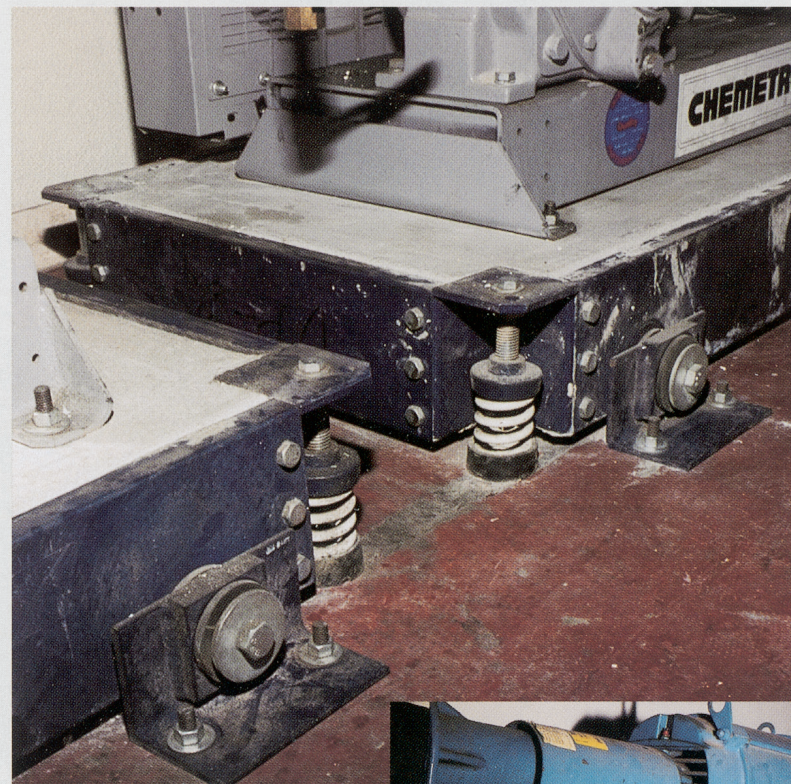
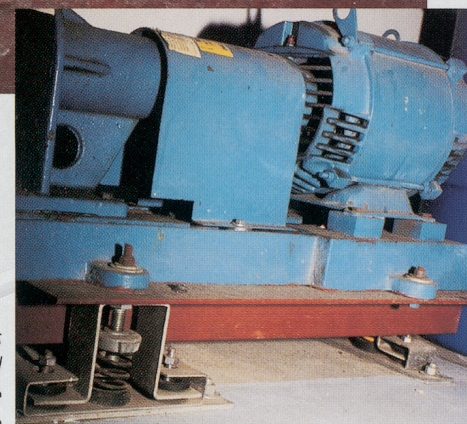
This pump system is mounted on a steel frame to minimize floor loading. The springs are inside a steel seismic housing with all directional elastomeric grommets to prevent hard surface impact. Anchor bolt edge distance was more than adequate and the system showed no sign of failure. (Mason MSL Base, SLRA Spring Mountings with extended base plates)

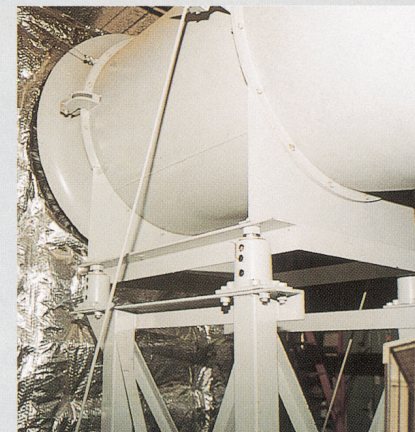
This excellent design uses square steel tubing as the support columns, cross braced by steel angles. The frame was securely fastened to the structure and the isolation positioned on top. Self-contained ductile iron, seismic mountings supported a supplementary steel base under the blower. The system was subjected to very high forces of 1.4gV and 1.2gH with no failure to the system. (Mason Industries' MS Lower Base, SSLFH Ductile Iron Seismic Mountings, MSL Steel Base)

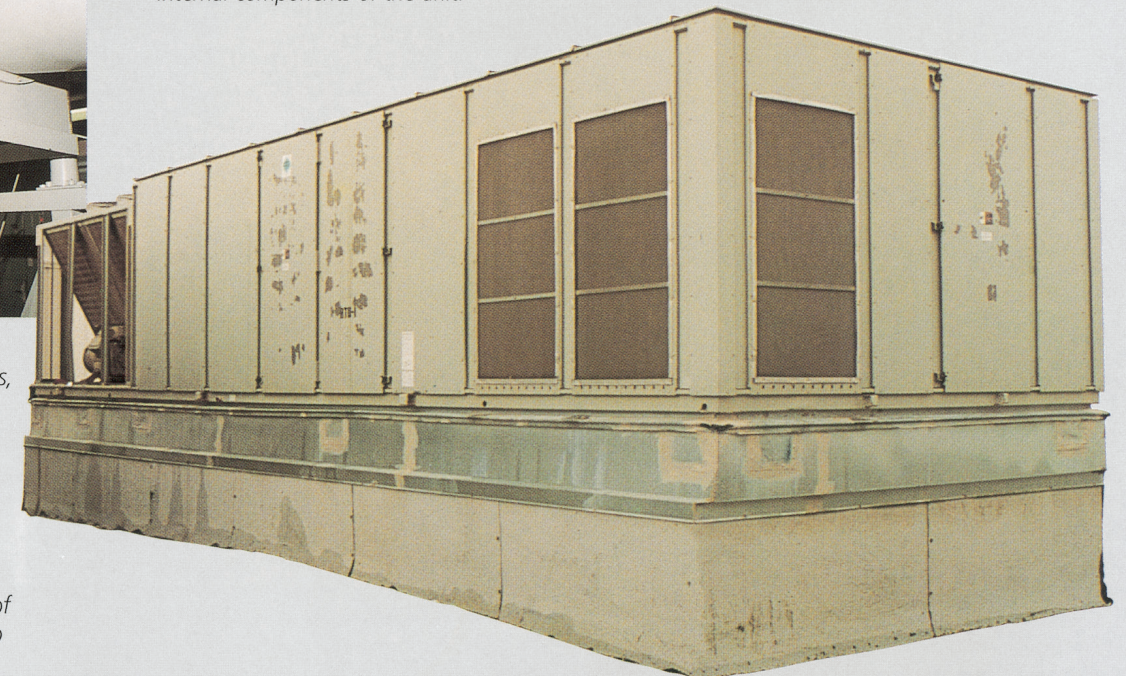
This properly designed seismically rated spring curb had resistances based on testing to allow for seismic input. The input forces were approximately 0.2gV and 0.25gH. The spring curb prevented damage to the lower support curb and the internal components of the unit.

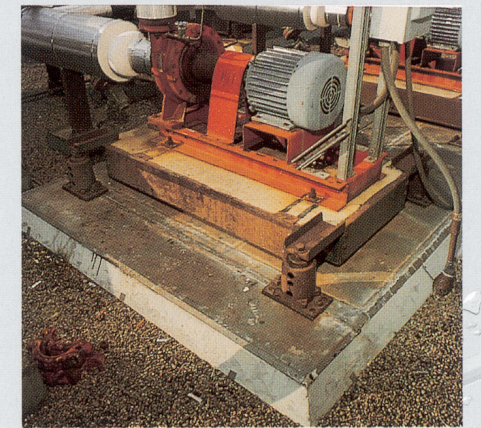
Shatter resistant ductile iron housings are the correct choice in seismic areas. Inputs were very high at approximately 1.5gV and 1.4gH. The systems did not fail because the entire load path was properly designed. Notice that the anchor bolts are widely separated and edge distances are very conservative. Both the floating concrete base and the housekeeping pad were properly reinforced and the housekeeping pad securely attached to the structure. (Mason BMK Base and SSLFH Ductile Spring Mountings)

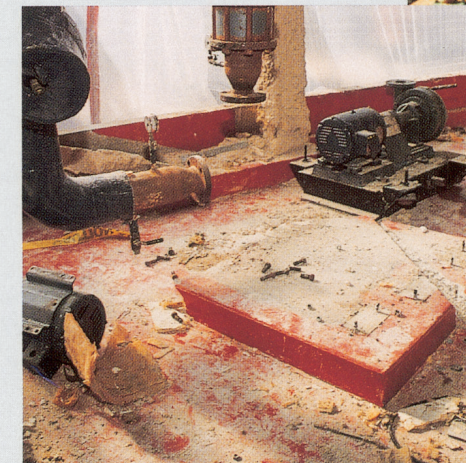
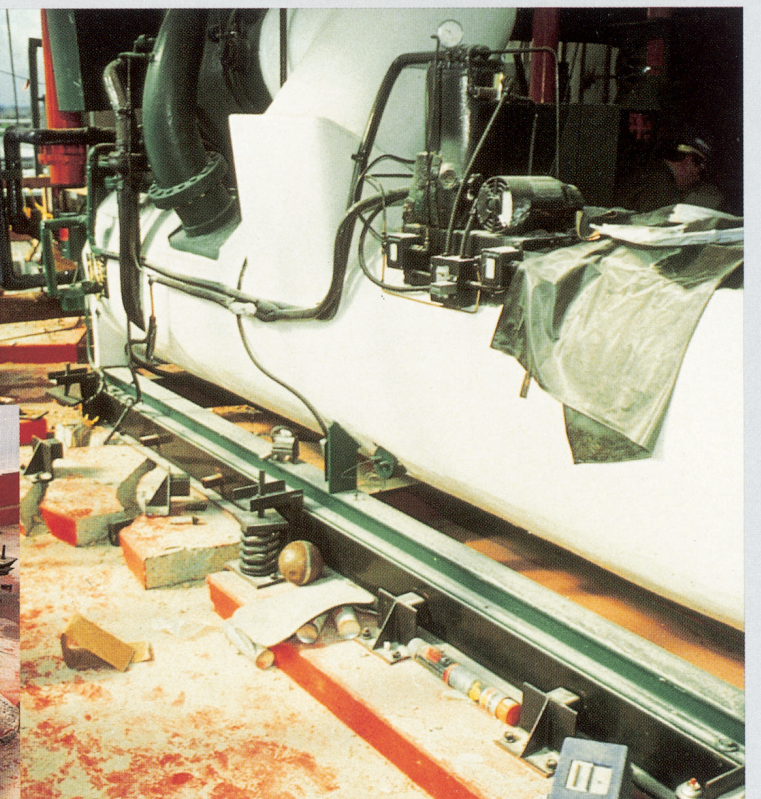
Housekeeping pad failures were common, because of improper doweling or fastening to the structural floor, and inadequate or no reinforcement in the pad itself. These pads, as the pads on the cover, had both problems. Inadequate fastening allows the pads to lift, chatter and shift. Poor reinforcement allows breakage. When the pads fail, the system must fail as nothing remains in place.

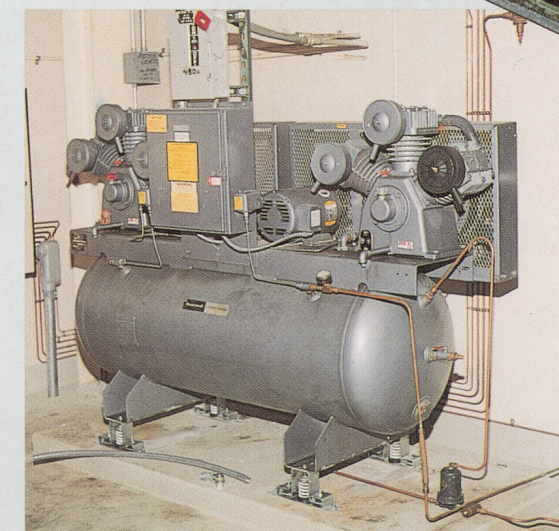
This is a simple isolation method for a horizontal tank mounted compressor (if the base legs are sturdy enough) without the use of a supplementary steel base. Mountings have built in seismic snubbers with ratings from OSHPD in the State of California. Not only these mountings, but similar designs were successful in every reviewed location. Forces were approximately 0.2gV and 9.25gH. (Mason SLRA Mountings)

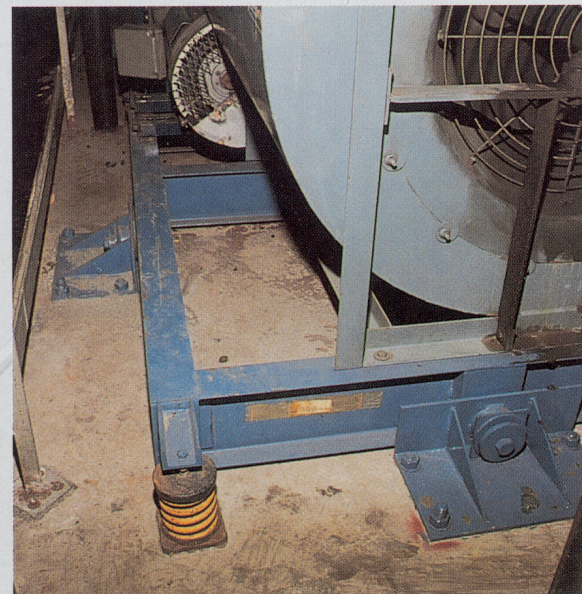
One of the proper ways to mount a fan and motor is to bolt the equipment to a rigid rectangular steel base. The spring mountings friction pads eliminate the need for bolting as the snubbers will limit motion. All directional thick Neoprene snubber bushings both restrain and cushion shock. (Mason WF Base, SLF Springs, Z-1225 Snubbers)

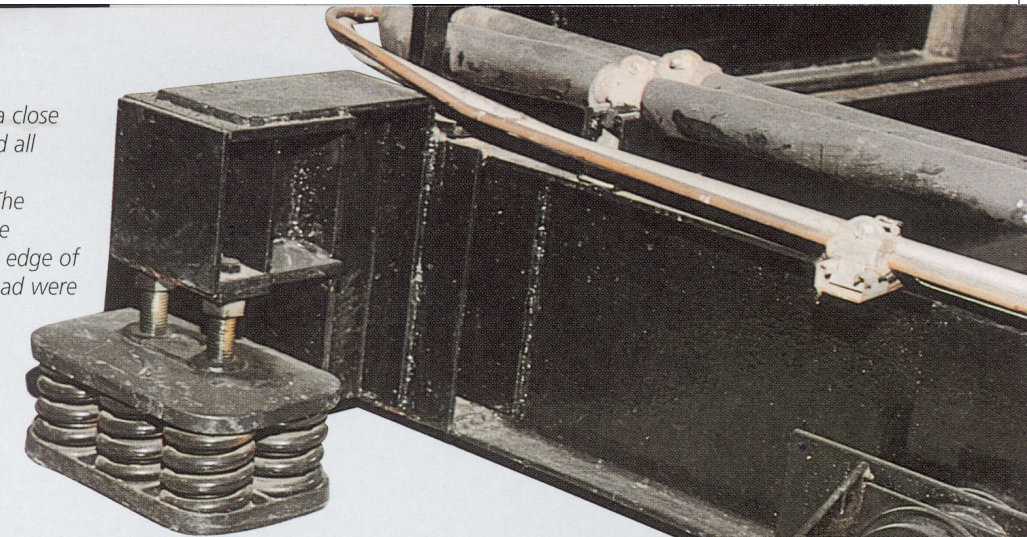
This photograph is a close up of the spring and all directional snubber installation below. The anchor bolts and the clearances from the edge of the housekeeping pad were all carefully calculated. (Mason WF Base, SLF Springs, Z-1011 Snubbers)

Chiller systems need not fail. The wide flange structural frame was supported by spring mounts under height saving brackets. Springs were not bolted down since the all directional seismic snubbers prevent excessive movement and spring failure. The maximum force was 0.3gV and 0.4gH.

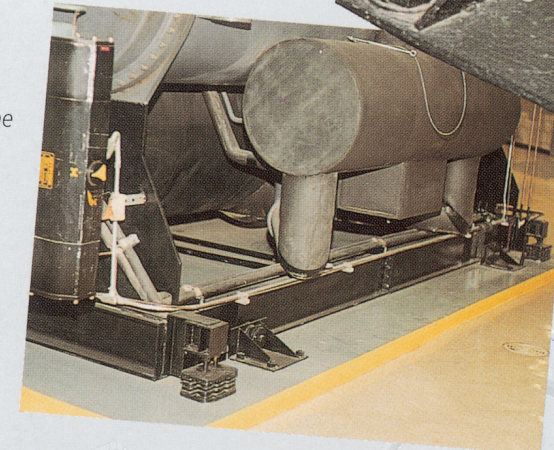
This is an excellent installation using a structural steel frame with height saving brackets and spring mounts with their own built in seismic protection. These are not malleable or gray iron, but ductile castings that will not shatter. The air cooled chiller has very light sheet metal legs which did not buckle, because the steel frame tied the four legs together. This unit was almost at the epicenter of the earthquake and saw seismic inputs of 1.0gV and 1.4gH. These are some of the highest forces ever recorded by an instrument anywhere in the world, but the installation survived intact. (Mason WF Base, SSLFH Snubbed Spring Mountings)

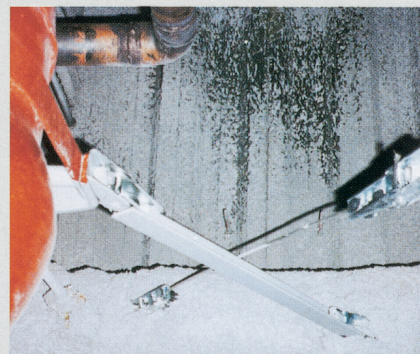
An unusual photograph showing both solid and cable braces. Both systems use swivel fittings specifically designed for the purpose to simplify installation and provide OSHPD approved attachment. Contractors often prefer cable to solid bracing even on non-isolated piping, because cables can be installed more quickly. (Cable Braces Mason Type SCB, Solid Braces Mason Type SSB)

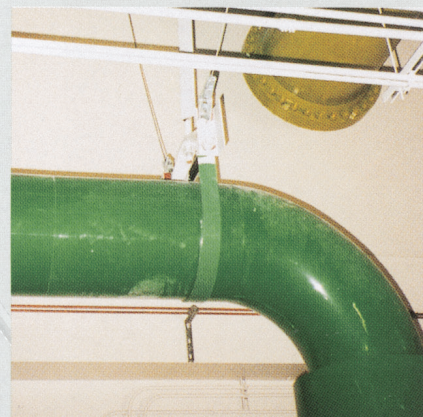
A typical example showing the use of a cable sway brace with swivel fittings for the specific purpose. Fittings are adjustable and the installation simplified by their use. (Mason Type SCB)

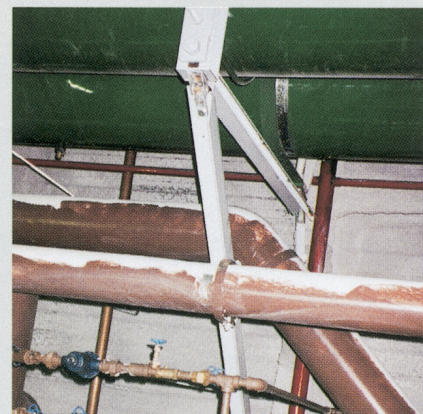
The swivel sway brace fittings at the ends of the angle iron brace eliminate welding, fitting and fabrication time. Solid sway braces can only be used on equipment that is not isolated. When equipment is isolated, bracing must be by cable or isolated devices to prevent transmission of vibration. (Mason SSB)

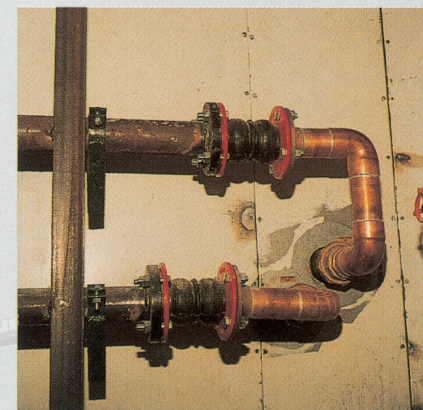
Even a very fragile copper pipeline with sweat fittings will survive at the equipment interface if proper flexible joints are used. This system was subjected to approximately 0.2gV and 0.25gH, and showed no signs of failure because of the flexibility of the twin sphere rubber connectors. (Mason Twin Sphere Superflex shown. Current improved design is Mason Safeflex.)
