### Reprint of Field Test Report

Sound & Vibration Attenuation  
of Actual Installation

# NEOPRENE CONNECTORS

TEST BULLETIN 902

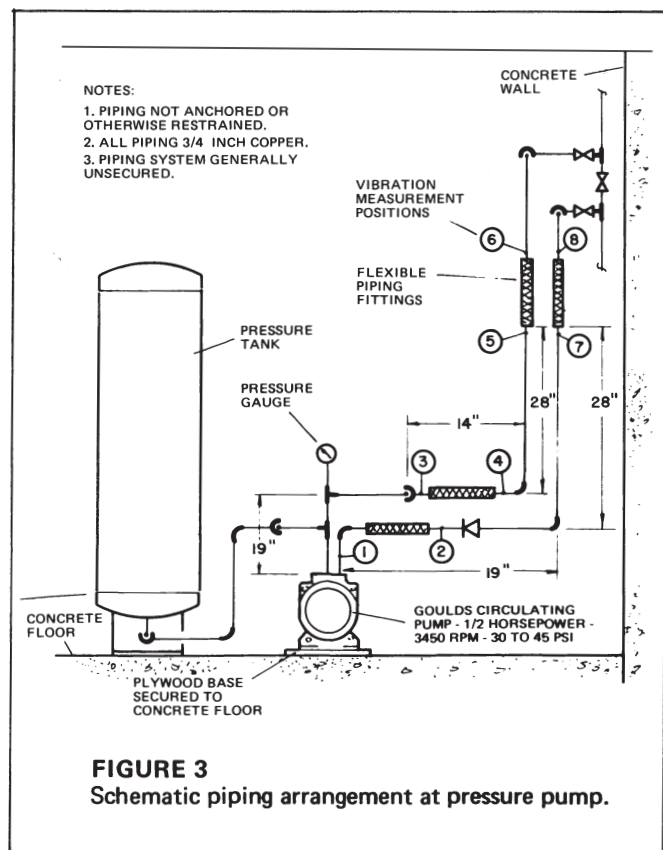
Vibration measurements were made in the same positions as those taken for the original units. The measurement position locations are shown in Figure 3. During the course of conducting sound and vibration measurements, the home intercom system was pressed into service to determine, from bathroom locations, whether the pump in the basement was operating or not.

About 1 November 1976 the installation of four Mason Industries 3/4 inch Twin-Sphere MFTFU Union Connector vibration isolation units was completed. (See Figure 2). The Mason units were installed in precisely the same locations as the original units which were removed. (See Figure 3)

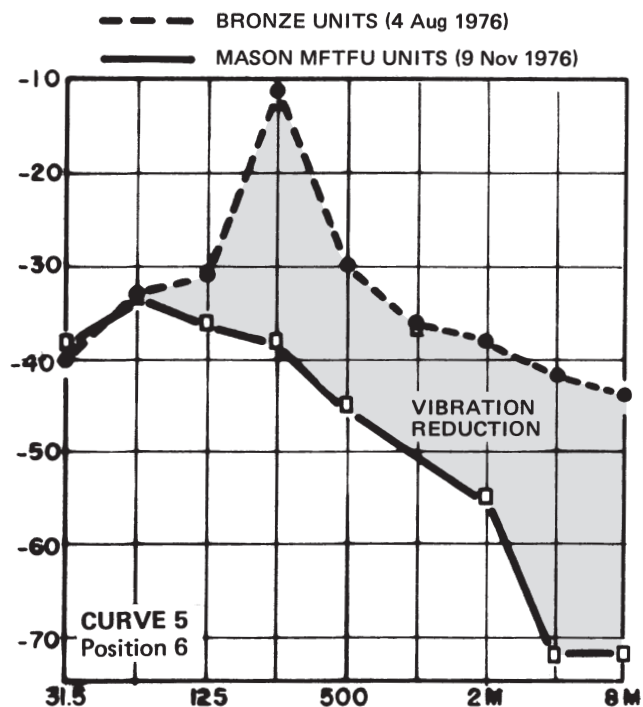
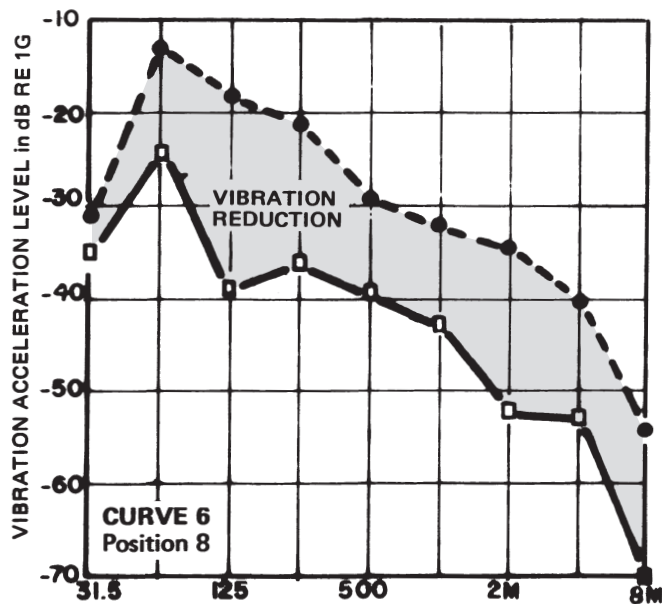
These vibration eliminators had been installed in May of 1973 to reduce the transmission of objectionable noise and vibration from a pressure booster pump to the living spaces of the house via the piping system. The application of these units did, in fact, attenuate vibration transmission and effectively reduce sound pressure levels measured in two bathrooms as shown in Curves 1 and 2.

Curves 1 and 2 graphically indicate the reduction in noise level in the two bathrooms resulting from the installation of the Mason units. A very significant noise attenuation was achieved from the pump impeller blade passage peak noise level in the 250 Hz octave band. The Goulds pump impeller has four blades, thus blade frequency increment  $4 \times 3450 / 60 = 230$  Hertz. Related reductions in vibration acceleration levels may be noted at 250 Hz on Curves 3, 4, 5, 6 and 7 plotting measured vibration levels at measurement positions 2, 4, 6 and 8. It is further observed that rather dramatic attenuation of vibration occurs from the 250 Hz through the 8000 Hz octave bands at measurement positions noted above with the following exceptions.

Conclusion: The installation of the Mason-Flex connectors reduced the noise levels in the top floor bathroom from NC 38 to NC 15 and in the main floor bathroom from NC 42 to NC 22 as compared to the bronze connectors. No tests were run in 1976 on solid piping but it can be assumed these levels would have been as high or higher than those of the installed bronze connectors.
