Reprint of Field Test Report
IMPACT AND AIRBORNE
SOUND TRANSMISSION
Conducted by
CERAMU AND ASSOCIATES
July 1974

FSN
FLOATING FLOOR
ACOUSTICAL
FIELD TEST
TEST BULLETIN 100

IMPACT AND AIRBORNE SOUND TRANSMISSION FIELD TEST REPORT

TEST LOCATION: 25th Floor T.V. Studio
Standard Oil of Indiana Building
Chicago, Illinois

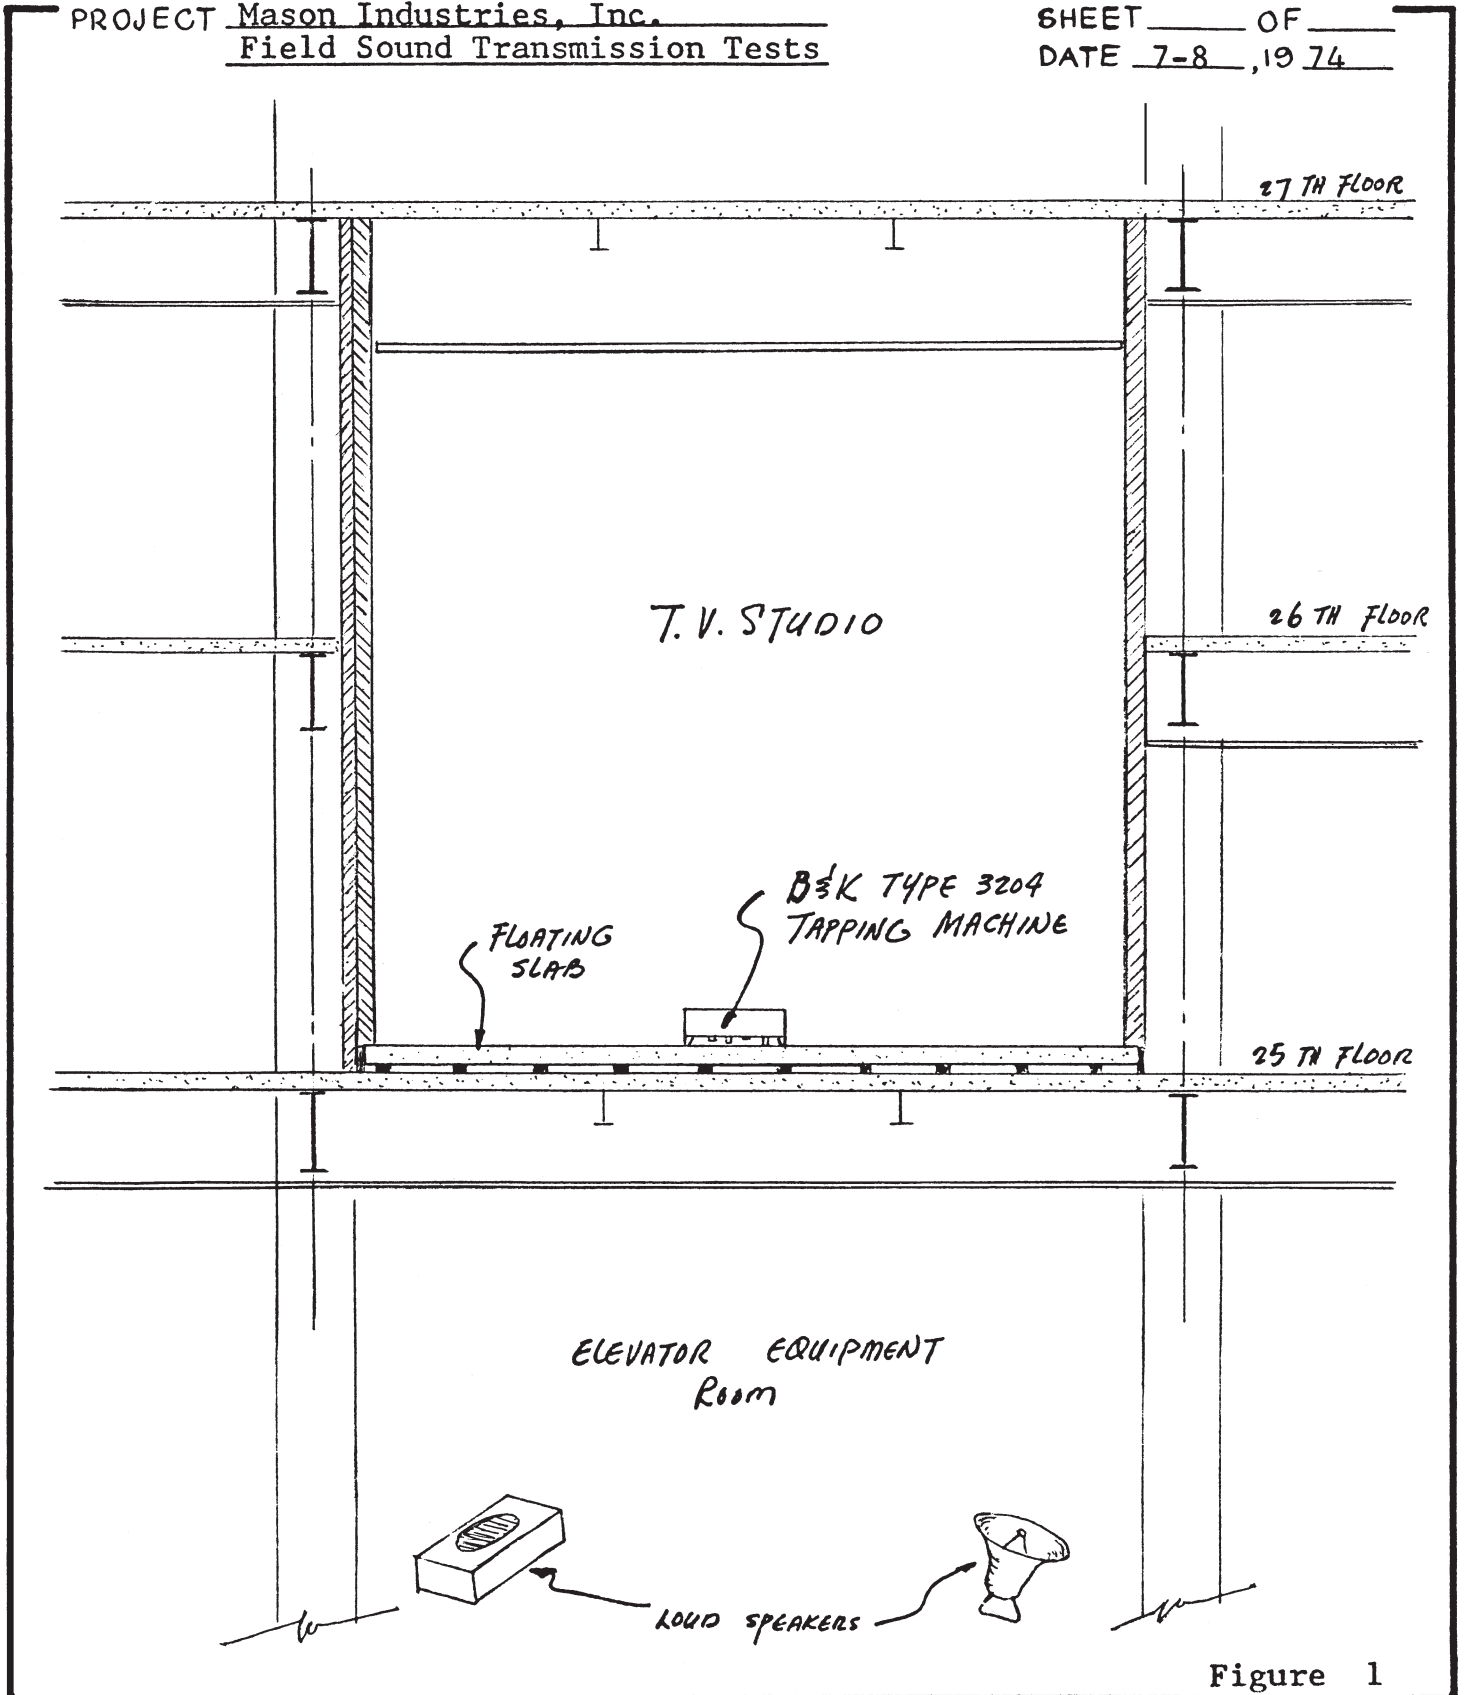
A general layout of the test configuration is shown on Figure 1 of this report.

The test specimen separates the 25th floor T.V. Studio and elevator equipment room on the 24th floor. For the Impact Test, the receiving room was the elevator equipment room. Measurements were made in the elevator equipment room in the late evening hours with all elevator equipment as well as ventilation equipment shut down in order to permit measurable sound pressure levels due to the Tapping Machine.

For the Airborne Sound Transmission Test, the elevator equipment room was used as the source room and the T.V. Studio was used as the receiving room so as to minimize the amount of time elevator equipment was shut down. Partitions around the T.V. Studio were partially supported on the test specimen floor as shown on Mason Industries drawing Z-1076. Furthermore, the ceiling over the T.V. Studio consisted of a resiliently suspended gypboard ceiling with a layer of 4 inch thick glass fiber blanket laid over the top.

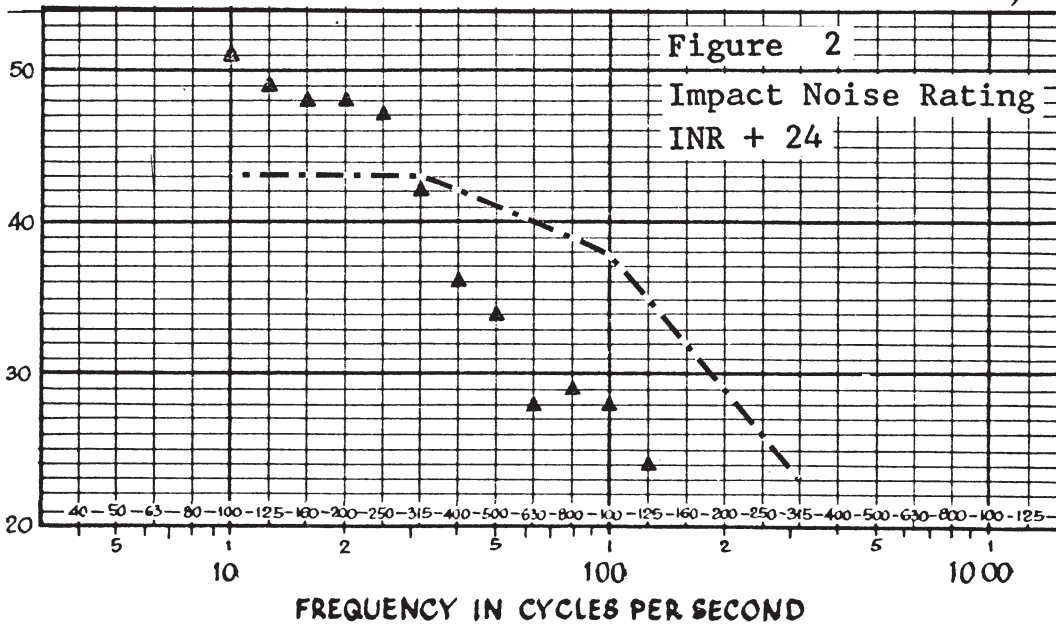
Normalized Impact Sound Level
THIRD OCTAVE BAND LEVEL IN DB RE 0.0002 MICROBAR

Graphical presentation of the above test results are shown in Figure 2 of this report.

<u>Center Frequency (Hz) in One-Third Octave Bands</u>	<u>Sound Pressure Levels (db) Normalized to $A_0 = 10 \text{ M}^2$</u>
100	51
125	49
160	48
200	48
250	47
315	42
400	36
500	34
630	28
800	29
1000	28
1250	24
1600	24
2000 2500 3150	*
Impact Noise Rating	<u>INR + 24</u>

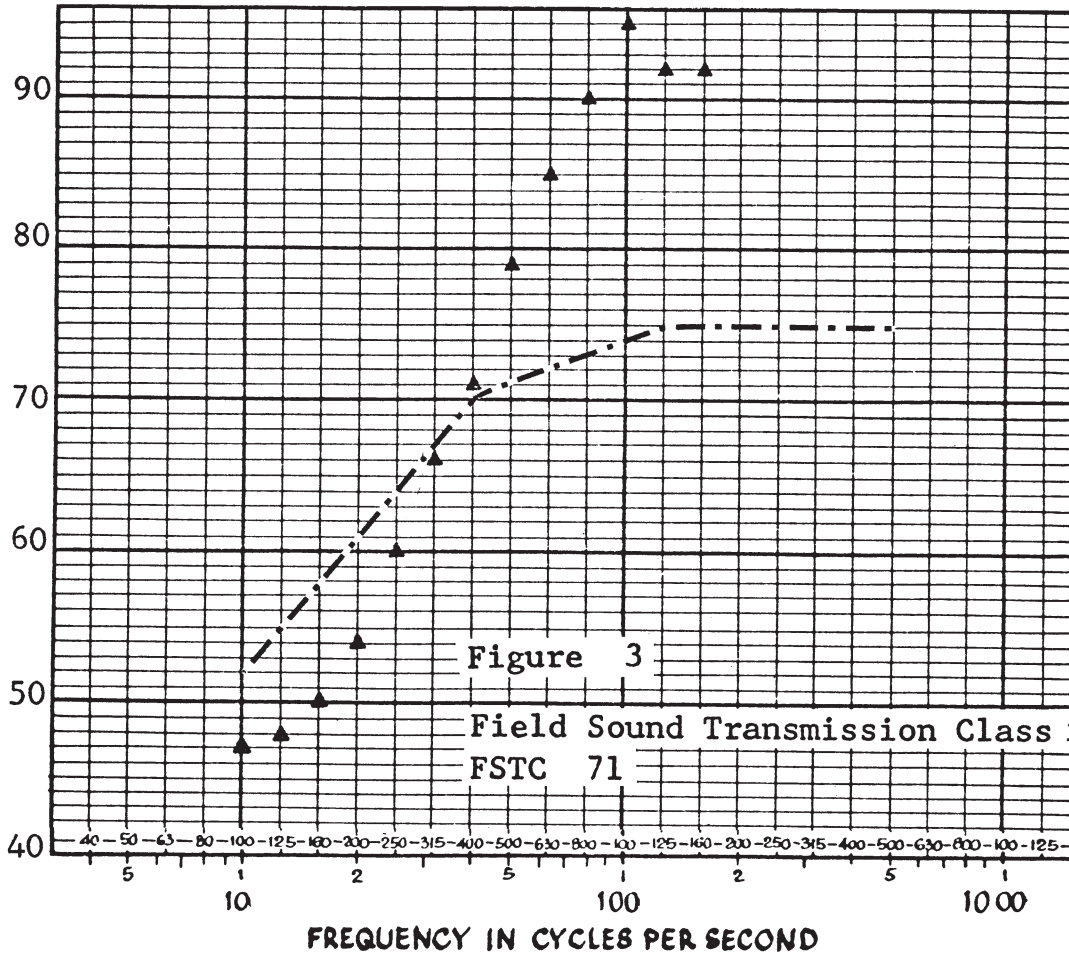
Graphical presentation of the above test results are shown in Figure 3 of this report.

<u>Center Frequency (Hz) in One-Third Octave Bands</u>	<u>Transmission Loss (db)₂ Normalized to $A_0 = 10 \text{ M}^2$</u>
100	47
125	48
160	50
200	54
250	60
315	66
400	71
500	79
630	85
800	90
1000	95
1250	92
1600	92
2000 2500 3150 4000 5000	*
Field Sound Transmission Class	<u>FSTC - 71</u>

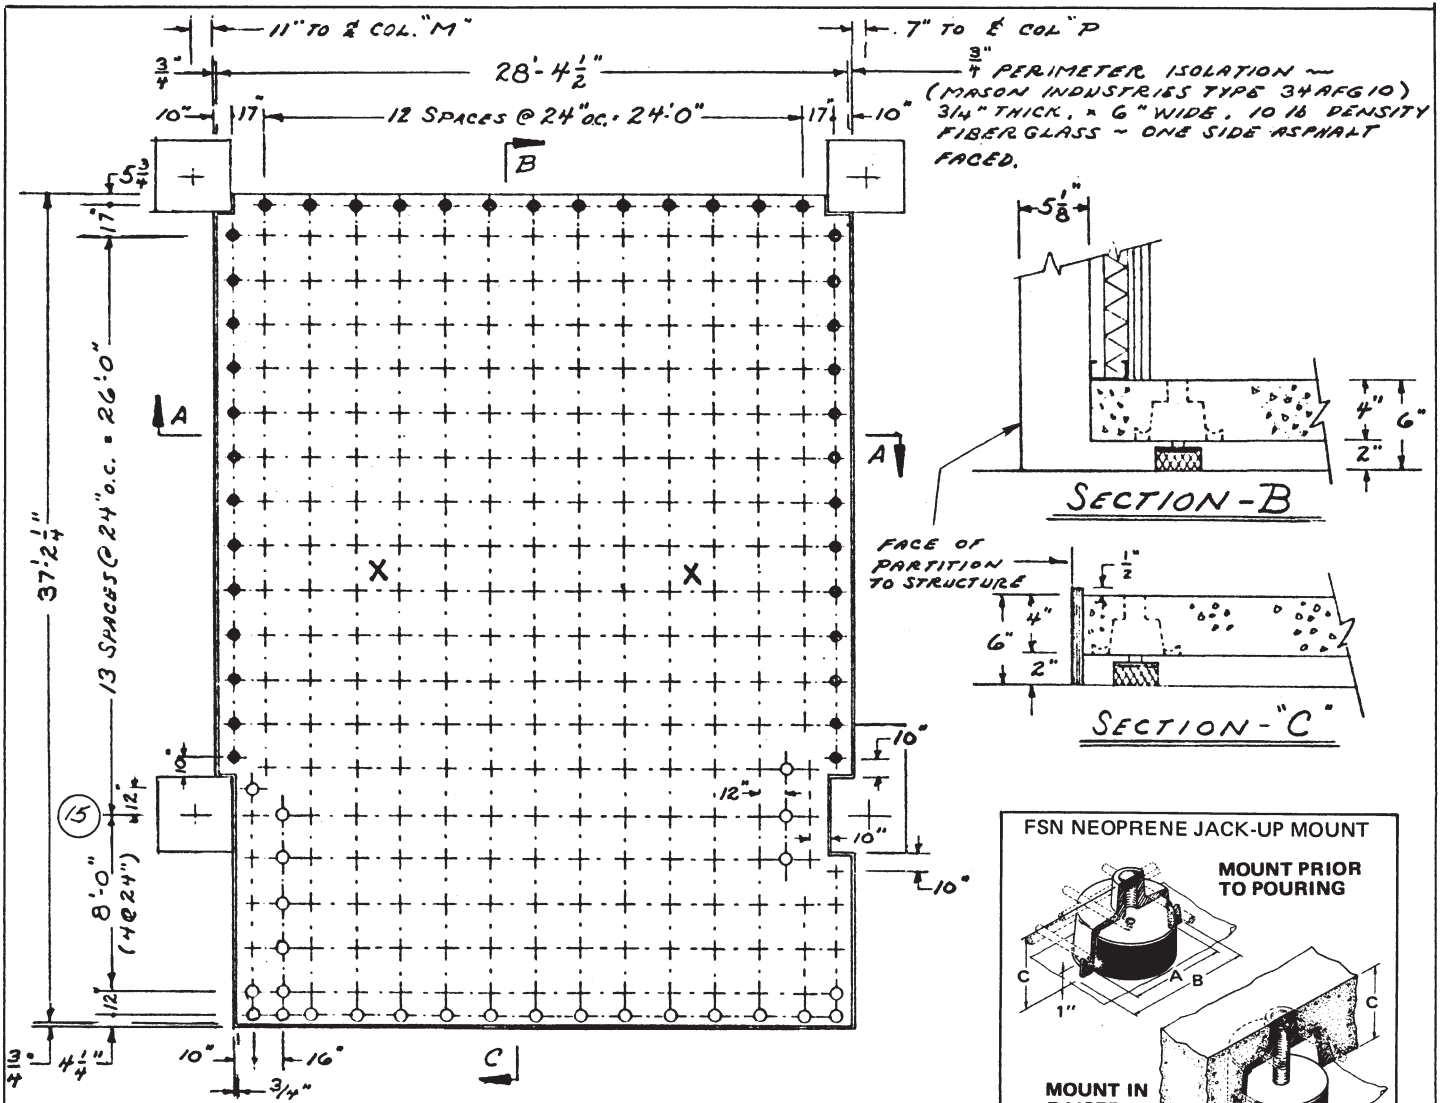
1. ISOLATORS HAVE BEEN SELECTED TO OPERATE AT BETWEEN 0.2 TO 0.3 INCHES OF DEFLECTION, BASED ON A COMBINED DEAD & LIVE LOAD OF 181 PSF.

FSN ISOLATOR LAYOUT
25th FLOOR STUDIO 'A'
STANDARD OIL CO (INDIANA) BLDG
CHICAGO, ILLINOIS

The test specimen consisted of a 4 inch thick reinforced concrete slab, with an average weight of 50 lb. per square foot, supported on a grid of Mason Industries Type FSN-1336 and 1337 mountings with Type EAFM neoprene elements. The mountings are spaced on 24 inch centers, supporting the 4 inch thick "floating slab" 2 inches above a 5-1/2 inch thick LWC structural slab weighing an average of 50 lb. per square foot. The floating slab was finished in the Studio with a layer of 1/8 inch linoleum flooring. The floating slab was isolated along its perimeter with Type 34AFG-10, 3/4 inch thick, 10 lb. density fiberglass boards. The test surface area was 1054 square feet. Dimensions and details of the test specimen are as shown in Mason Industries drawings Z-1075-1 and Z-1076.

Test equipment consisted of the Bruel & Kjaer Tapping Machine Type 3204, which was placed at two (2) positions on the test floor. Sound pressure levels were measured in one-third octave bands in the receiving room by using the General Radio Noise and Vibration Analyzer Type 1564A, and corrected for ambient noise levels in the receiving room. Test results represent the arithmetic average of the two positions measured. Test positions are indicated with "X" marks on drawing Z-1075-1.

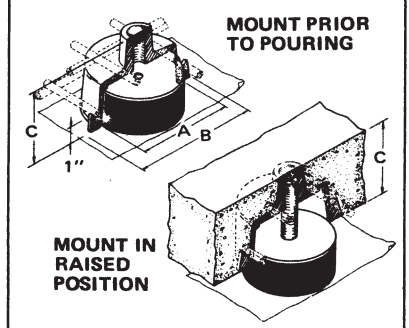
FSN NEOPRENE JACK-UP MOUNT

Load Range (lbs)	A (in)	B (in)	Min C (in)	Max C (in)
50 to 825	4-5/8	5-1/2	3	As Req'd
200 to 1365	5-3/8	6-1/4	3	As Req'd

Lowest Dynamic Frequency
7.5 Hertz @ 0.3" Deflection. (60 Duro)

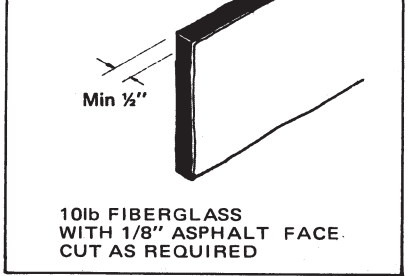
AFG-10 PERIMETER ISOLATION BOARD

PERIMETER ISOLATION -
(MASON INDUSTRIES TYPE 34AFG10)
3/4" THICK, 6" WIDE, 10 LB DENSITY
FIBERGLASS - ONE SIDE ASPHALT
FACED.

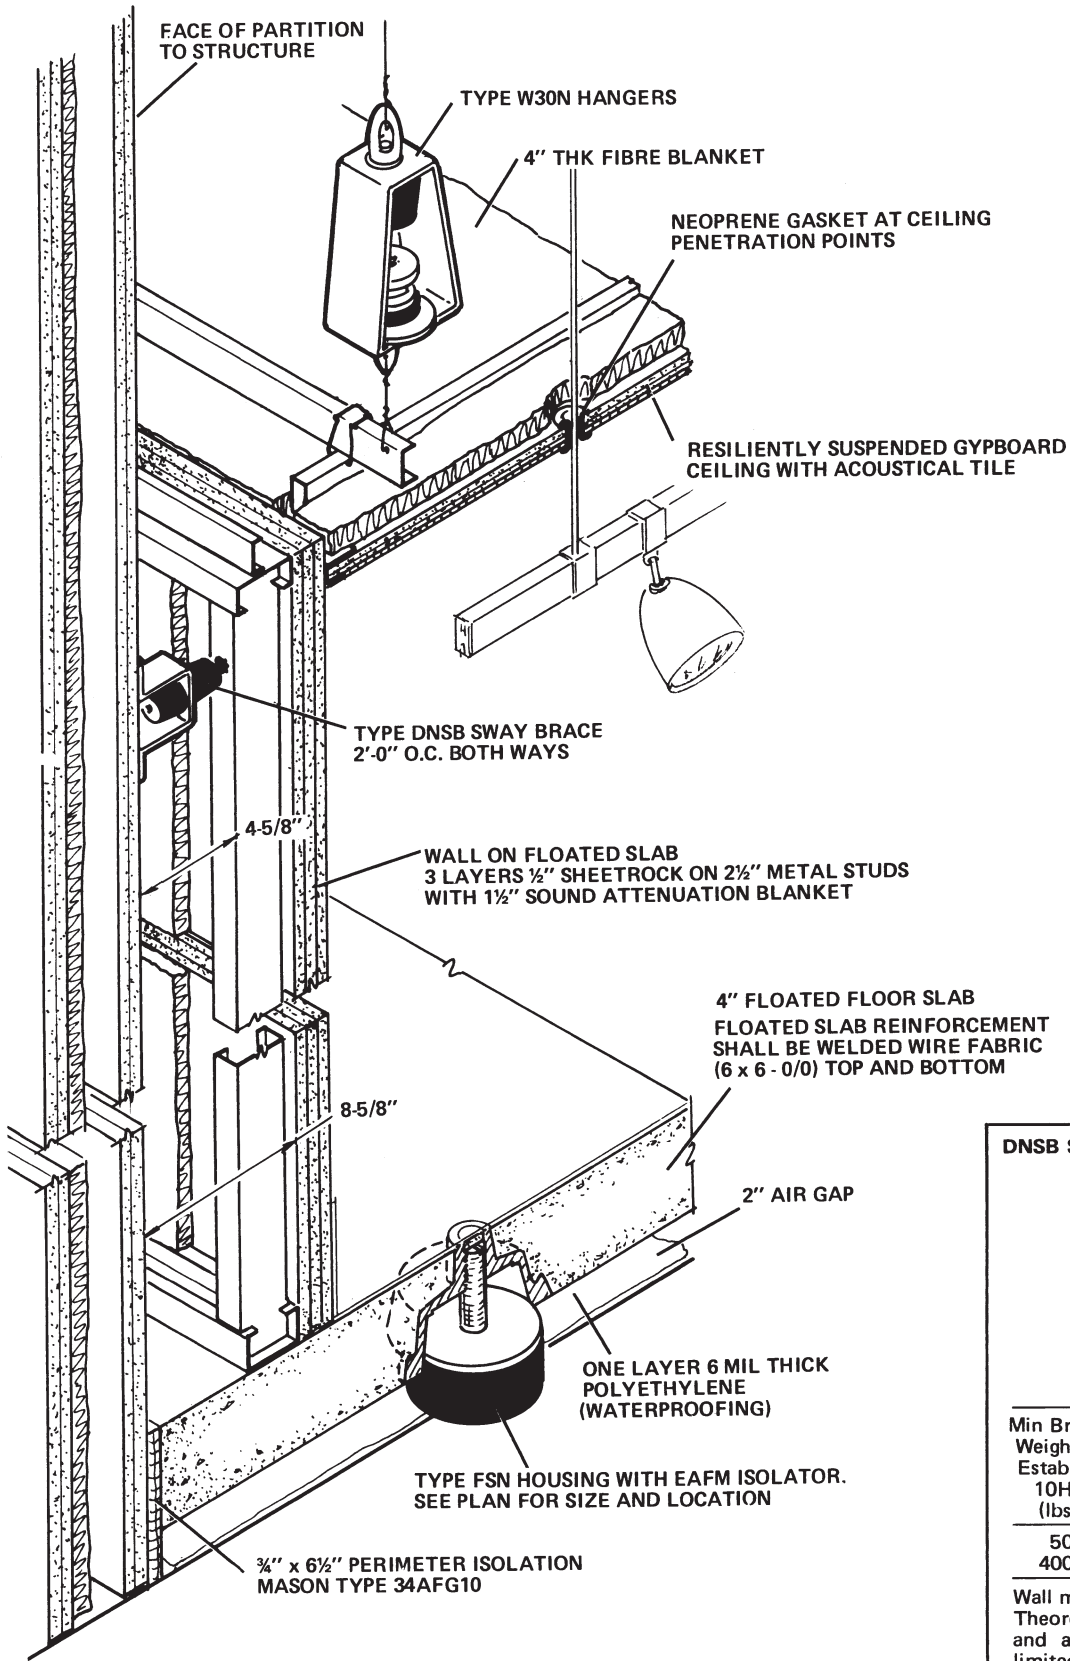
Z-1076a

DNSB SWAY BRACE

Wall must be supported at the base. Theoretical horizontal load is zero and assigned maximum weight is limited by possible development of buckling or overturning forces.

SECTION A TO Z-1075
